Smoky Canyon Mine

Pilot Study Report

**Zero-Valent Iron Treatment Technology – South
Fork Sage Creek Springs**

July 2012

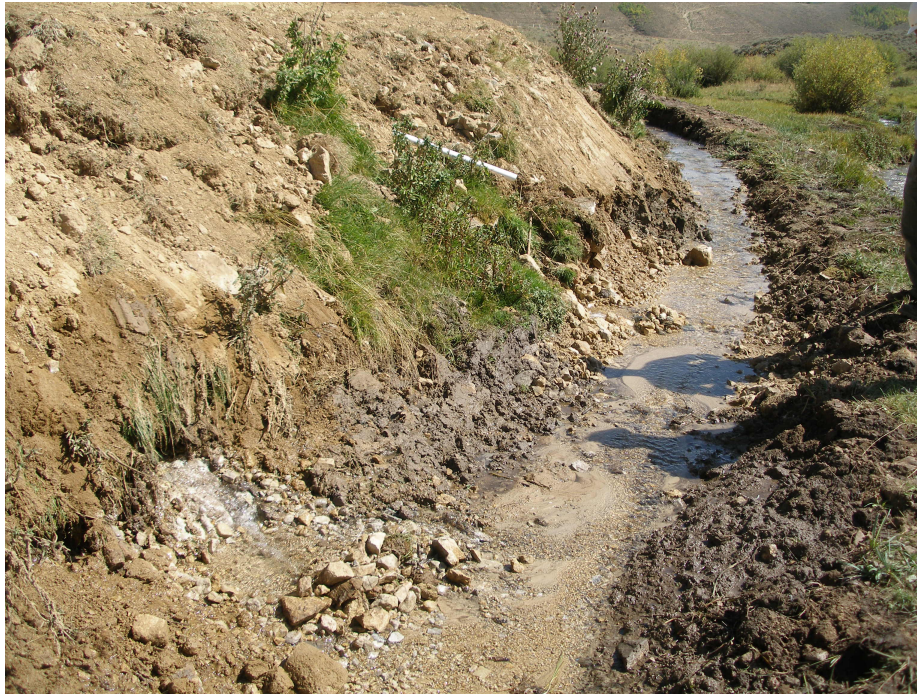
Figure 3-2: Photo showing trench prior to lining and pipe installation.

A trench was dug along the north side of the South Fork Sage Creek springs area to intercept spring water containing elevated selenium concentrations (Figure 3-2). The trench was lined with a geotextile fabric and a perforated pipe to collect all the spring water intercepted. The northern springs were initially thought to have a combined flow rate of 25 gpm (NewFields 2009b), but after construction of the pipeline, the flow rate from the northern springs was approximately 100 gpm. The intercepted water was directed by the pipe to a chamber where the majority of the spring water was returned to the creek while a portion flowed into a buried plastic pipe that fed the Liberty pilot system.

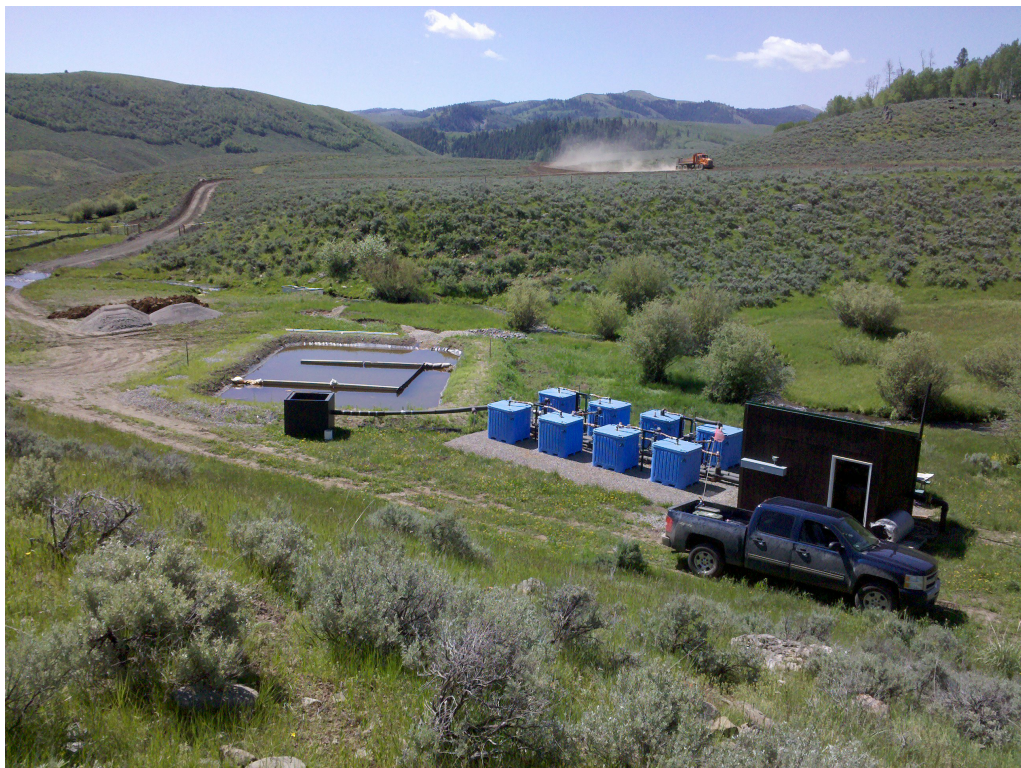
Figure 3-3: Photo showing treatment system control structure, totes, and settling pond.

The treatment system was below the spring discharge elevation; allowing the pilot system to be gravity fed. The pipeline entered a small structure in which there was a shutoff valve, an influent flow totalizer, and a sample port. The pipeline exited the structure and entered a manifold system designed to feed water to the individual treatment units. The influent spring water was split to feed eight identical 'totes' containing the ZVI media in a parallel configuration (Figures 3-3 and 3-4). The totes and associated piping all sat on a level gravel pad. Each tote was approximately four feet wide by four feet deep by four feet tall, with a treatment capacity of 3 gpm, and a contact time between the water and ZVI media of 1 to 2 hours (depending on the porosity in each tote). Water flowed through a valve, a visual flow meter, downward through the media, and exited from the bottom of the tote. The water flowed up through a stand-pipe (designed to keep the media saturated) before entering a manifold that combined the effluent from all the totes. There was a sample port present just after the stand-pipe to facilitate sampling of the effluent from each individual tote.

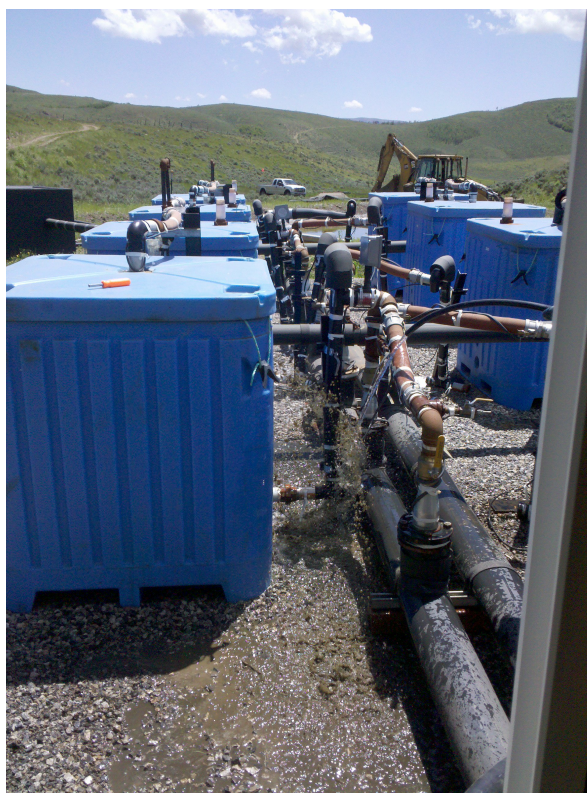
Figure 3-4: Photo showing tote piping manifold.

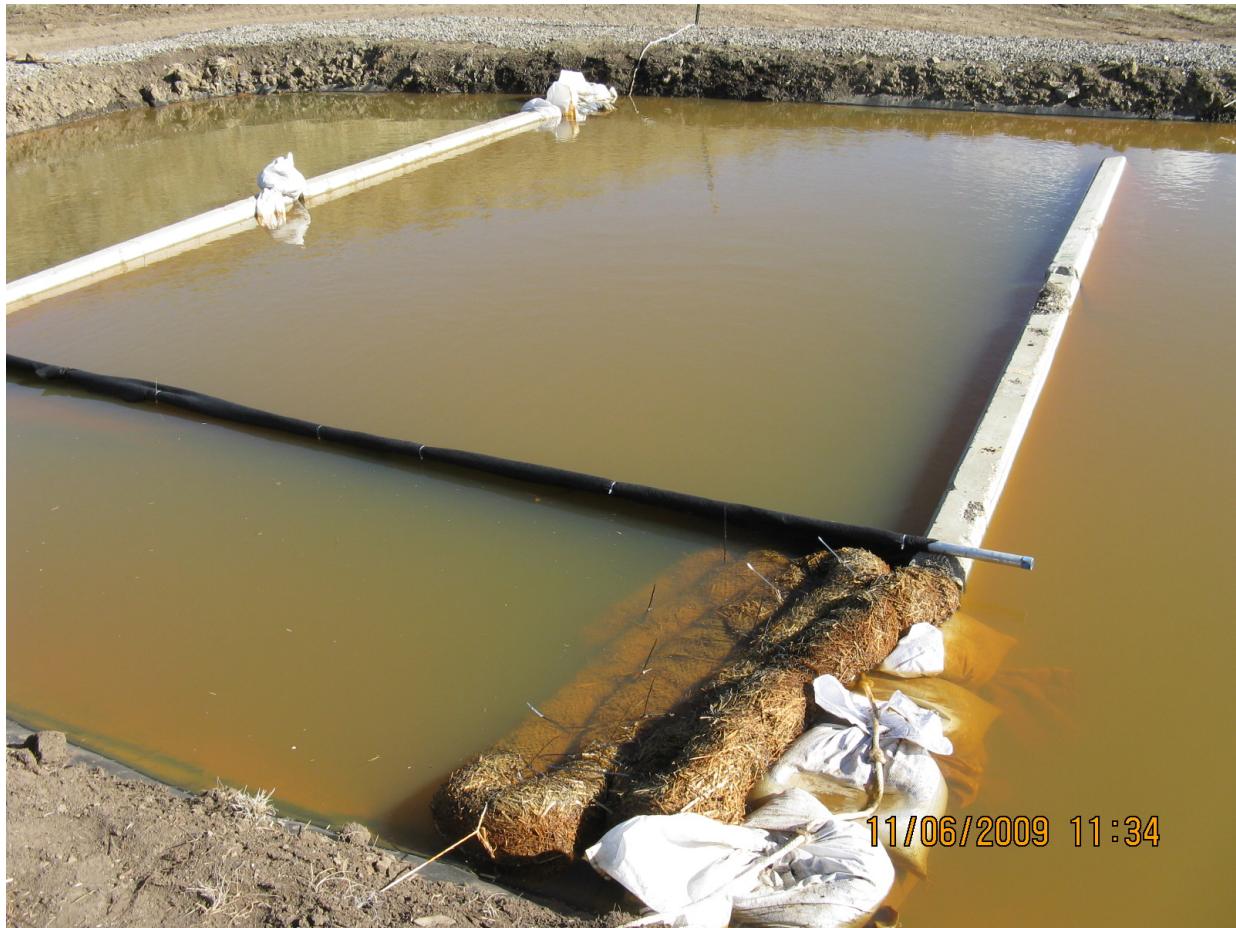
Figure 3-5: Photo showing aeration/settling pond.

The treated effluent water from the ZVI system contained dissolved and particulate iron as well as reduced dissolved oxygen (DO) levels. Therefore, the pilot system included aeration step/settling pond prior to discharge to the creek. The combined effluent discharged into a concrete drop structure that began the re-aeration process (a detailed description is provided in Section 3.4). The water exiting out of the drop structure entered into the oxidation/settling pond (Figure 3-5). The pond capacity was approximately 25,000 gallons with a surface area of approximately 8,000 square feet. At the system's maximum flow rate (24 gpm), the residence time of effluent water in the pond was approximately 17 hours. The pond contained two concrete baffles to minimize the potential for 'short-circuiting'. The pond discharged to an open channel containing a series of small gravel-lined ponds before returning the treated effluent to South Fork Sage Creek. The channel was initially 50-100 feet long but was reconstructed in late-October/early-November 2009 so that it was approximately 150 feet long with additional pools to enhance aeration/iron removal (Figure 3-6).

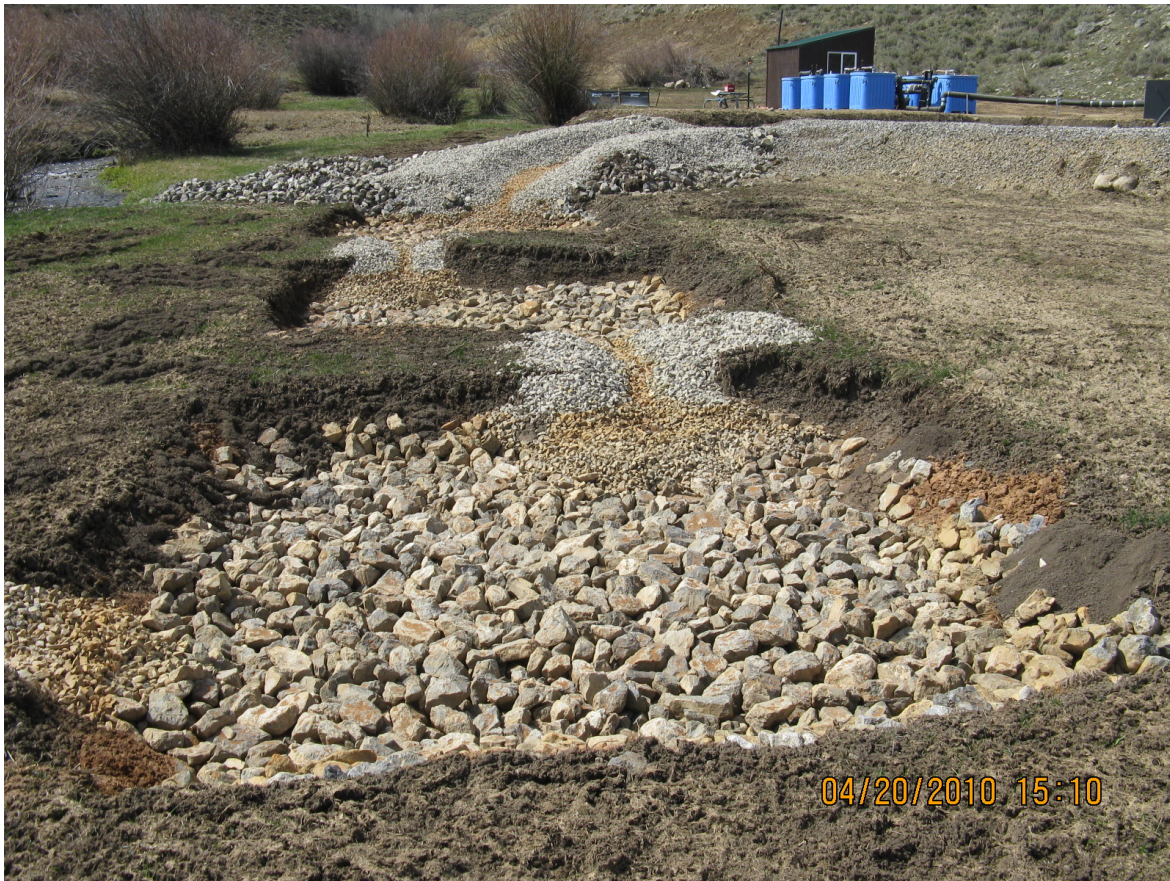
Figure 3-6: Photo showing aeration channel.

The discharge channel between the oxidation/settling pond and South Fork Sage Creek Springs was reconstructed in late-October to not only enhance re-aeration but to also enhance retention of the iron particulates. The initial discharge channel was approximately 75 feet long where the water discharged from the pond through a gravel bed and into a shallow pool before discharging to the creek. Over a period of a few days, the initial discharge channel was overwhelmed with iron particulate as additional treatment units were brought online. The reconstruction more than doubled the length of the discharge channel (see Figure 3-6).

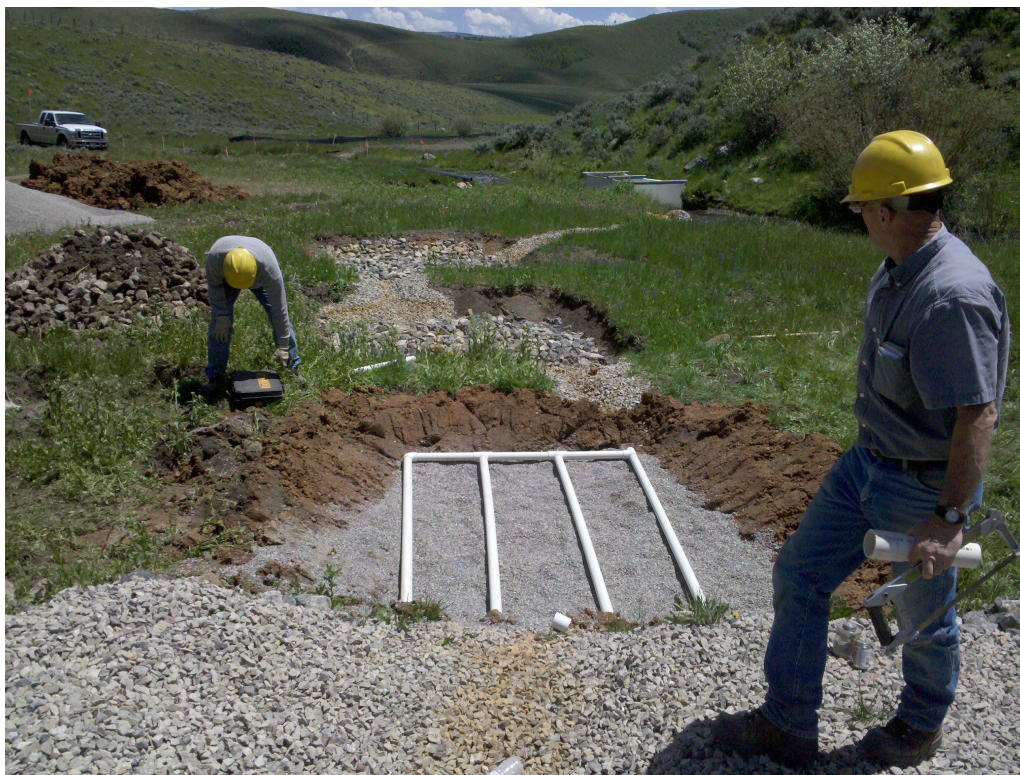
Figure 3-10: Photo showing installation of buried plastic pipe manifold for sand filter

On June 21 Simplot completed construction of a sand filter between the treatment pond and the aeration channel (Figures 3-10 and 3-11). The treatment system was brought back online and reached full treatment capacity (24 gpm) on June 23, 2010. The treatment system was run at full capacity from June 23, 2010 to August 3, 2011. The purpose of the second operating phase was to observe how the system performed over a longer period of time, including warmer summer months and a full winter. This section summarizes the performance of the system for the second operating phase.

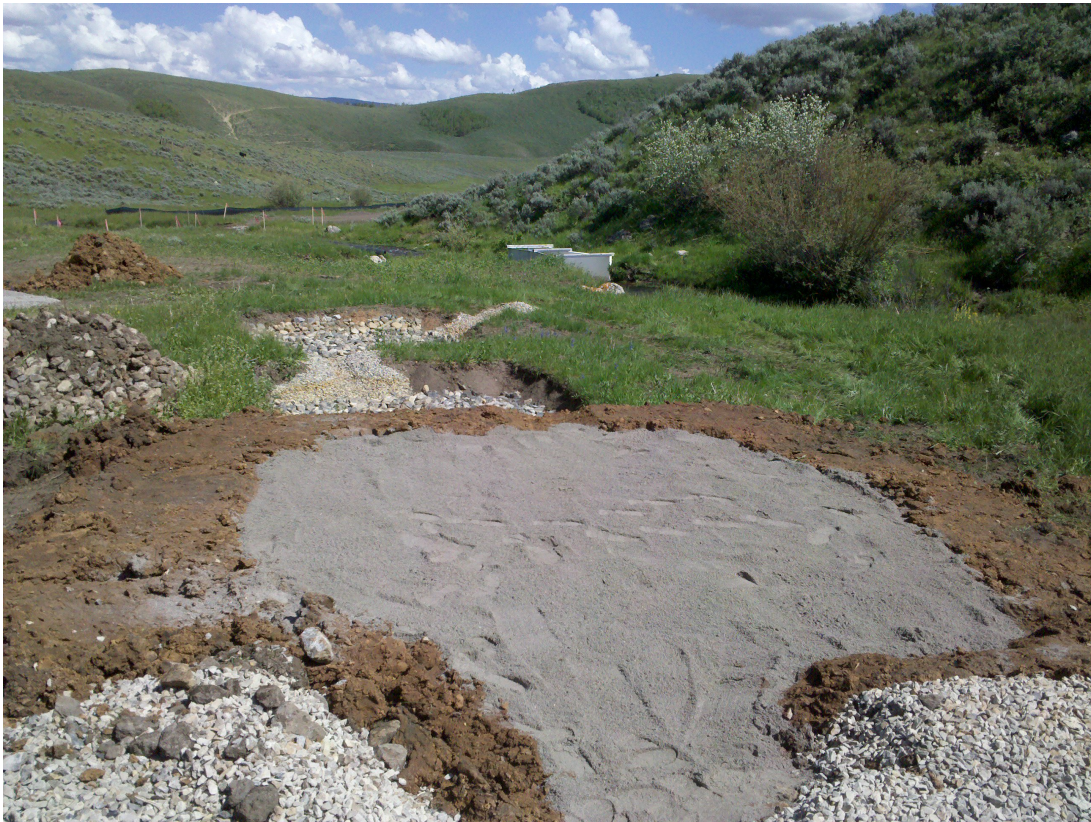
Figure 3-11: Photo showing sand filter.

When the system was restarted on June 23, 2010, the sand filter was not capable of passing all 24 gpm due to air pockets within the sand. Approximately 2 gpm (8% of total flow) was bypassing the sand filter. By June 26, 2010, the air pockets had been purged from the media and all 24 gpm was passing through the sand filter. On July 7, 2010, the sand filter had begun to show signs of plugging with approximately 2 gpm bypassing the filter. On July 13, 2010, the bypass flow rate had increased to 6 gpm. After monitoring the treatment system, the flow to the treatment units was temporarily shut off and the upper few inches of the sand filter was scraped to remove accumulated iron particulate. When the flow was restored to the treatment units, all of the water passed through the sand filter. This cleaning process was repeated periodically throughout the rest of the pilot study.
